BROWNFIELD REDEVELOPMENT ASSESSMENT REPORT

PACKARD PLANT COMPLEX

DETROIT, MICHIGAN

March 24, 1998

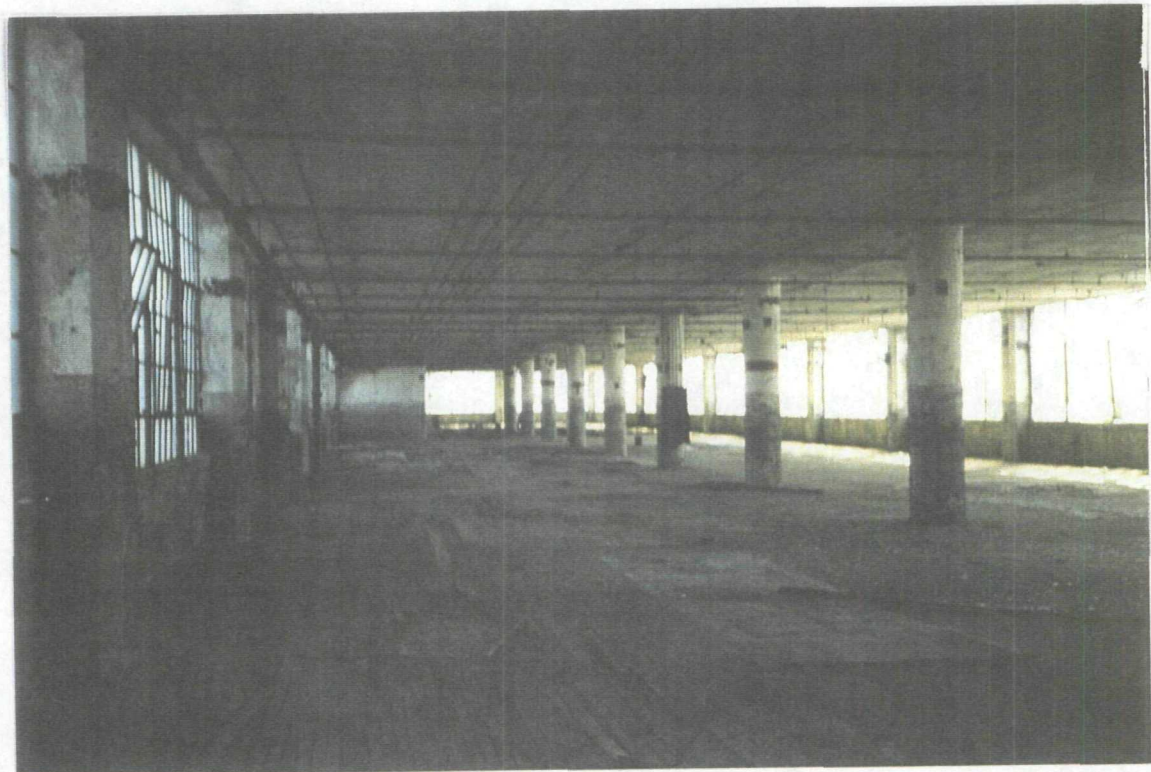
Third floor of Building 38 looking west to east.

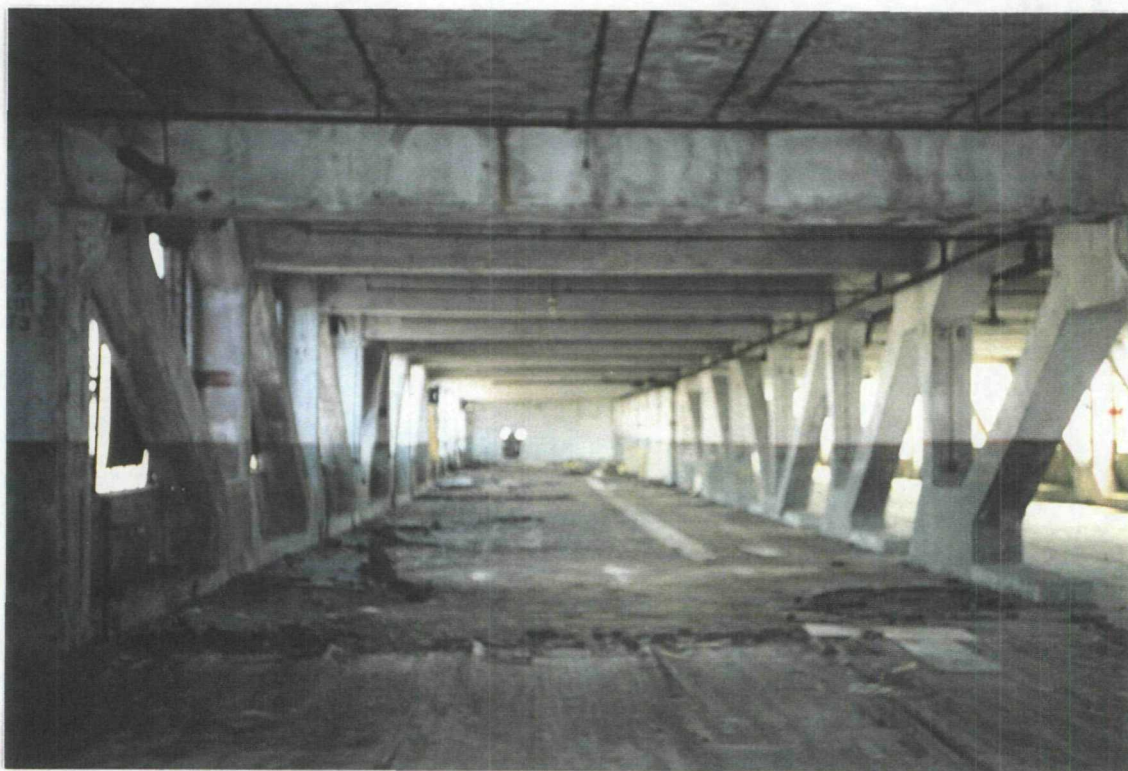
Third floor walkover Palmer Avenue looking toward the Central Complex- Building 28.

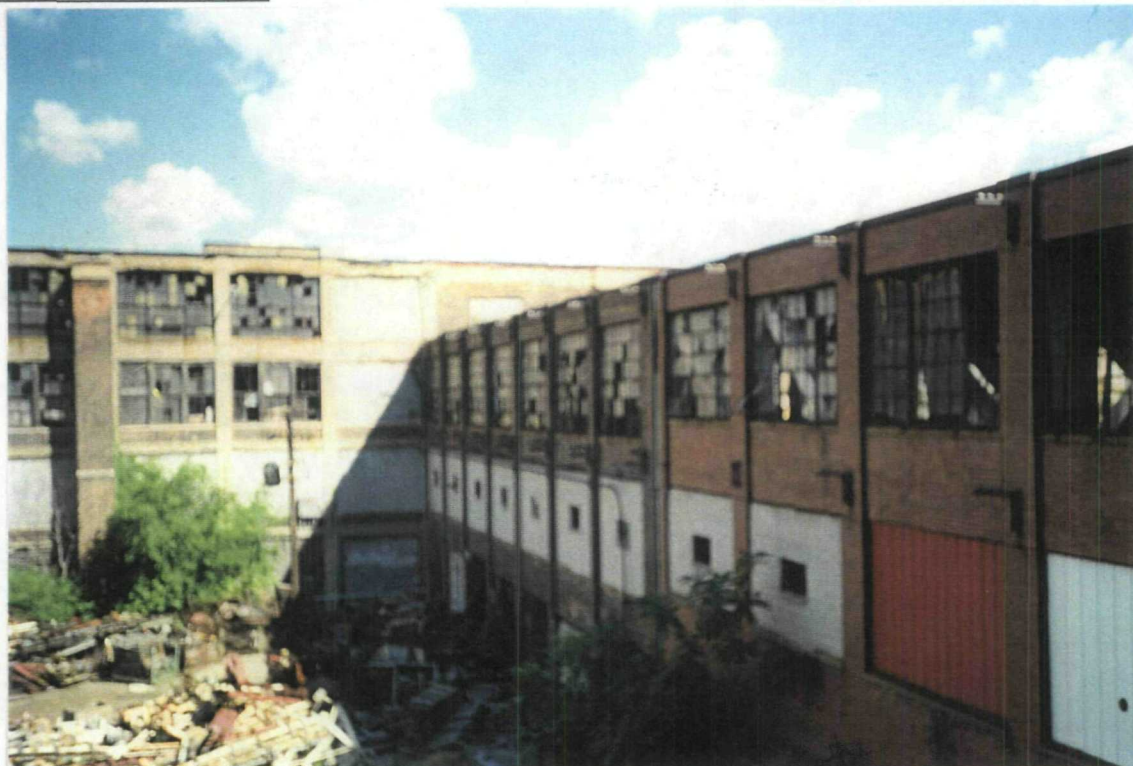
Walkover Palmer Avenue from Building 31 looking north to Building 28.

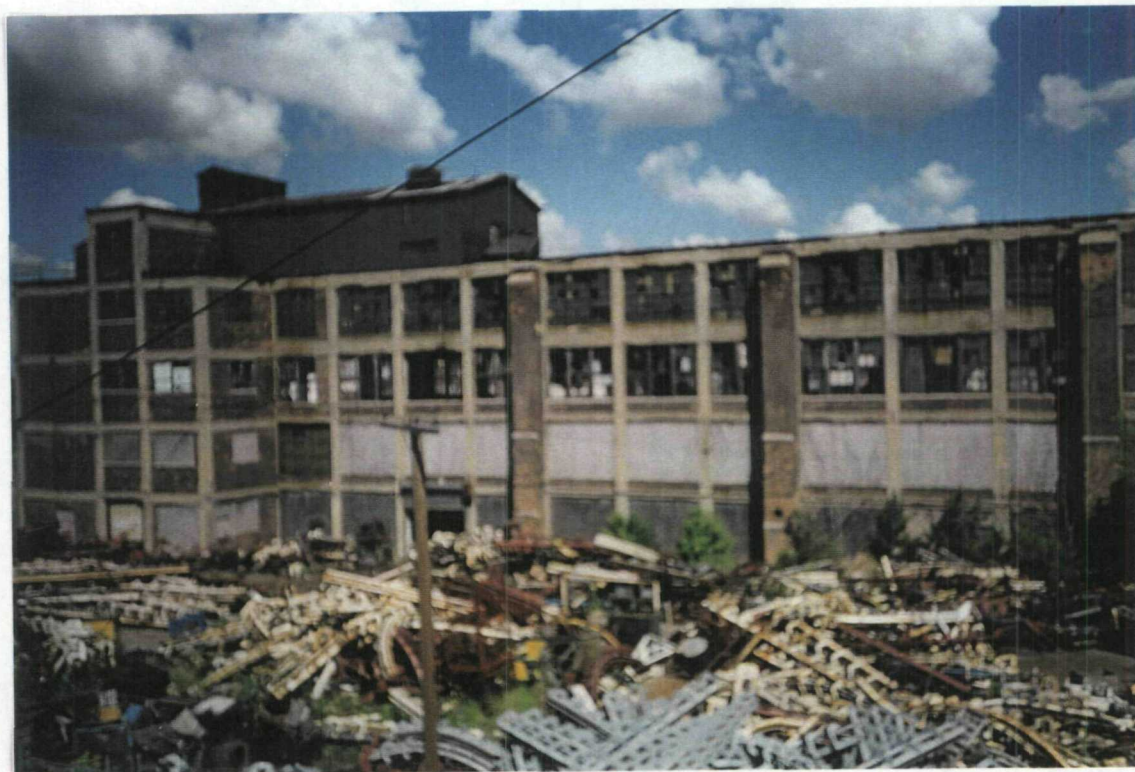
Flokey scrap metal storage area near Building 28.

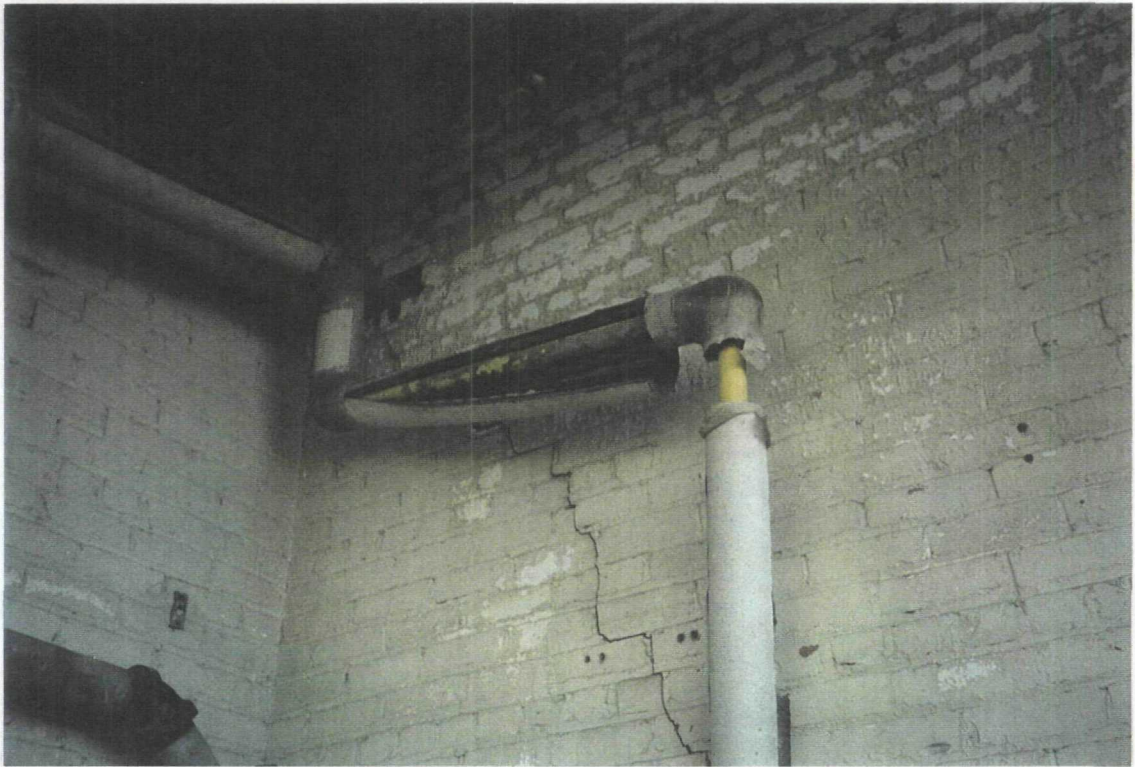
Asbestos pipewrap (aircell) in bathroom on the third floor of Building 92, northeast corner of floor.

- Increased security may prevent further dumping of refuse and other materials around the exterior of Building 92.
- All regulated asbestos containing material (ACM) in the complex should either be removed from the buildings or encapsulated during any revitalization of the structures. Removal of ACM must follow National Emissions Standards for Hazardous Air Pollutants (NESHAP) guidelines. Asbestos observed in the tenant occupied areas of the complex (first floors of Buildings 2,4,4C,10,10C,15,15C, 17, 17C, 19, 19C, 21, 31 31C) were well maintained and pose little to no risk to the workers. Asbestos observed in the vandalized or vacant portions of the complex was torn and hanging from the pipes or scattered over the floors exposing the fibers and creating a risk of inhalation exposure.

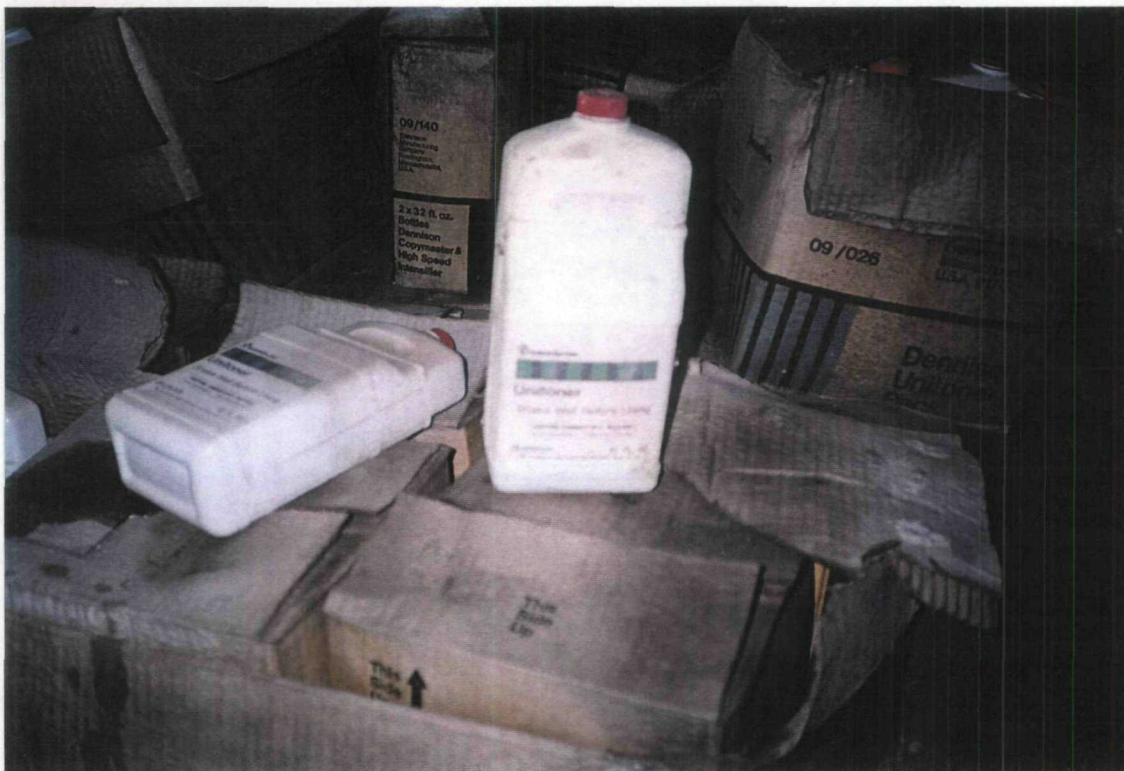
Dennison Unitoner, flammable material piled on Fourth Floor of Building 92 in the northwest corner. VOA reading of 300+ ppm.

- Sampling of drum contents and removal of all drums and containers found throughout the complex, especially on the first floor of Building 23, the fifth floor of Building 18-16-11-12 and the fourth floor of Building 92.

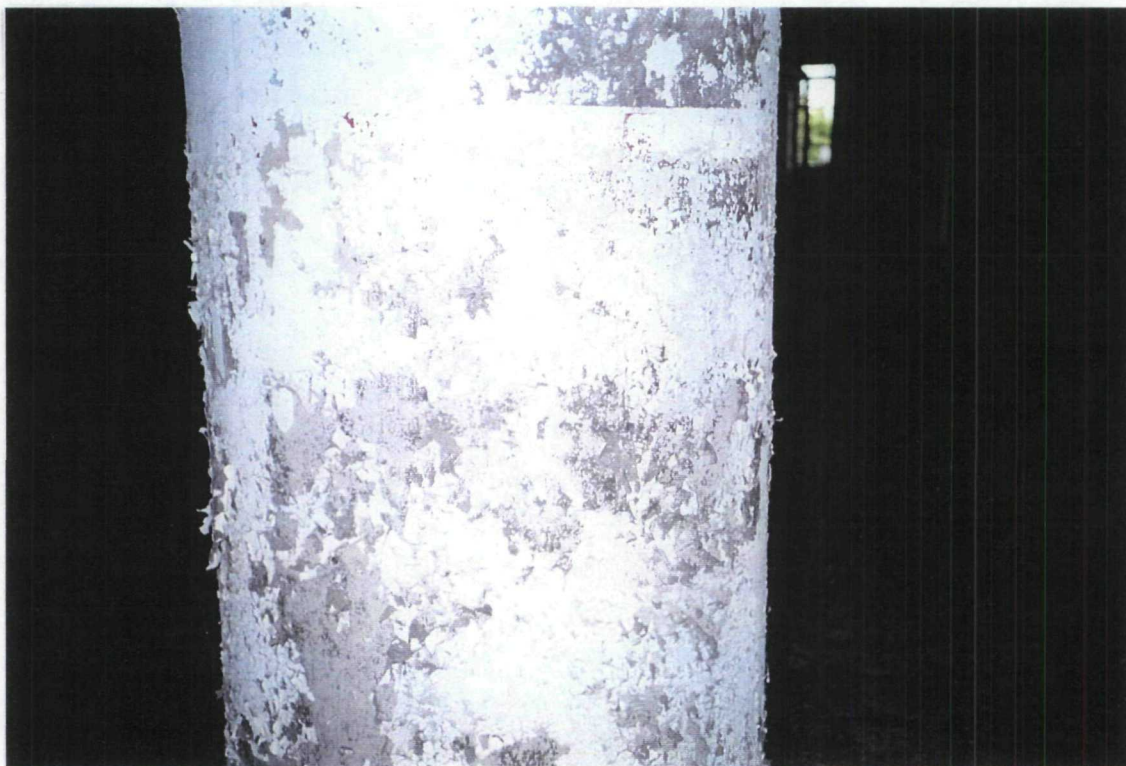
Peeling paint from column on third floor of Building 92.

- Elevated concentrations of lead in paint throughout the complex. Intact lead based paint poses little threat to human exposure via the direct contact route. However, peeling lead based paint which was observed in portions of the complex buildings or removal of lead based paint during renovation, may release paint particle dust which may pose an inhalation threat to workers and nearby resident populations.

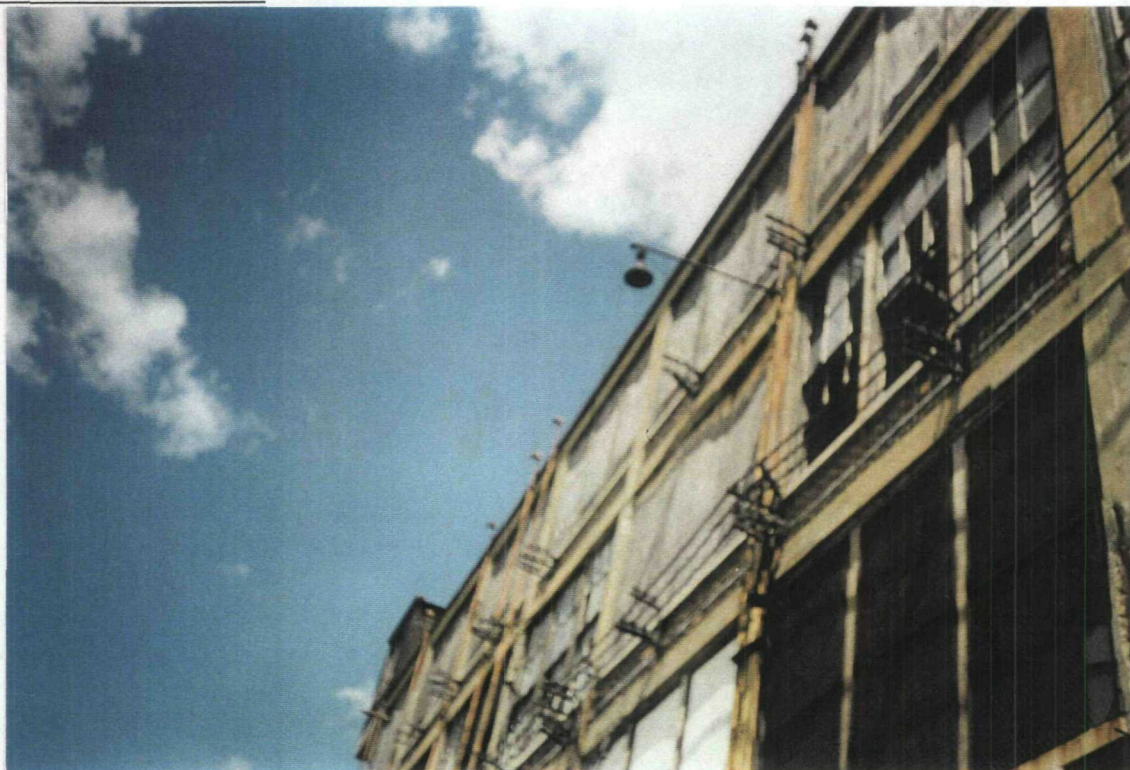
Vent pipes along outer west wall of Building 9, northwest corner.

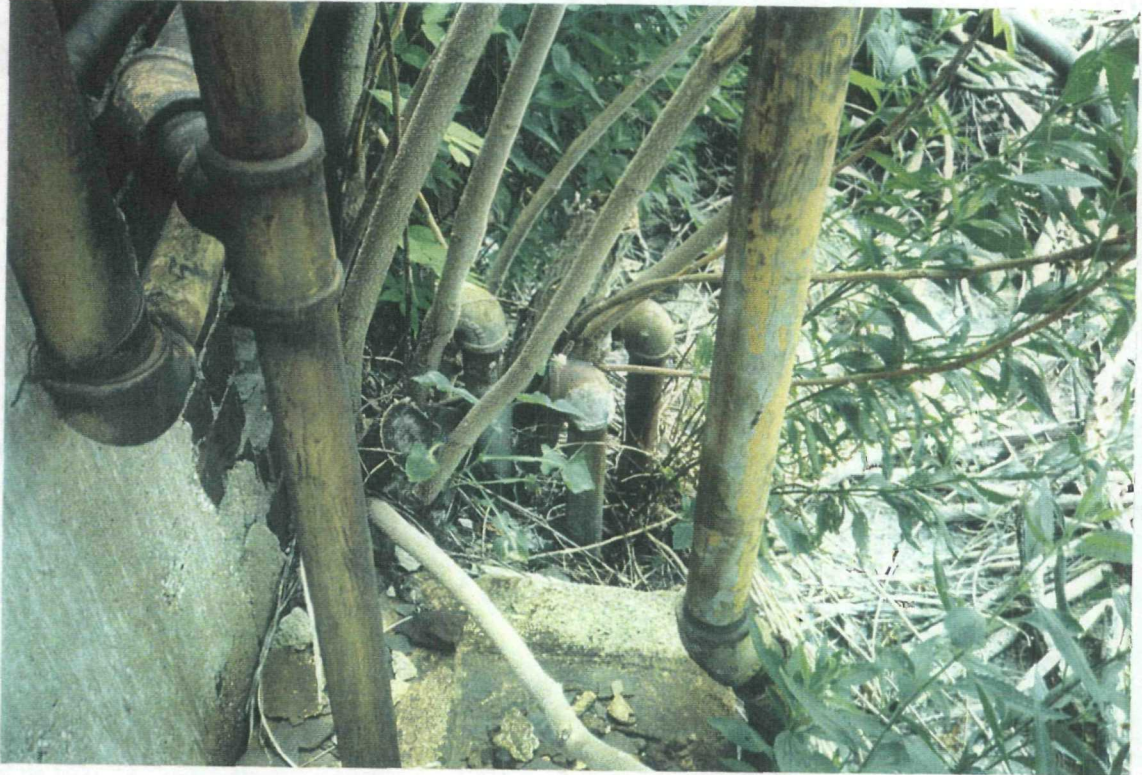
DESCRIPTION:  
Pipe sticks at northwest corner of Building 9.

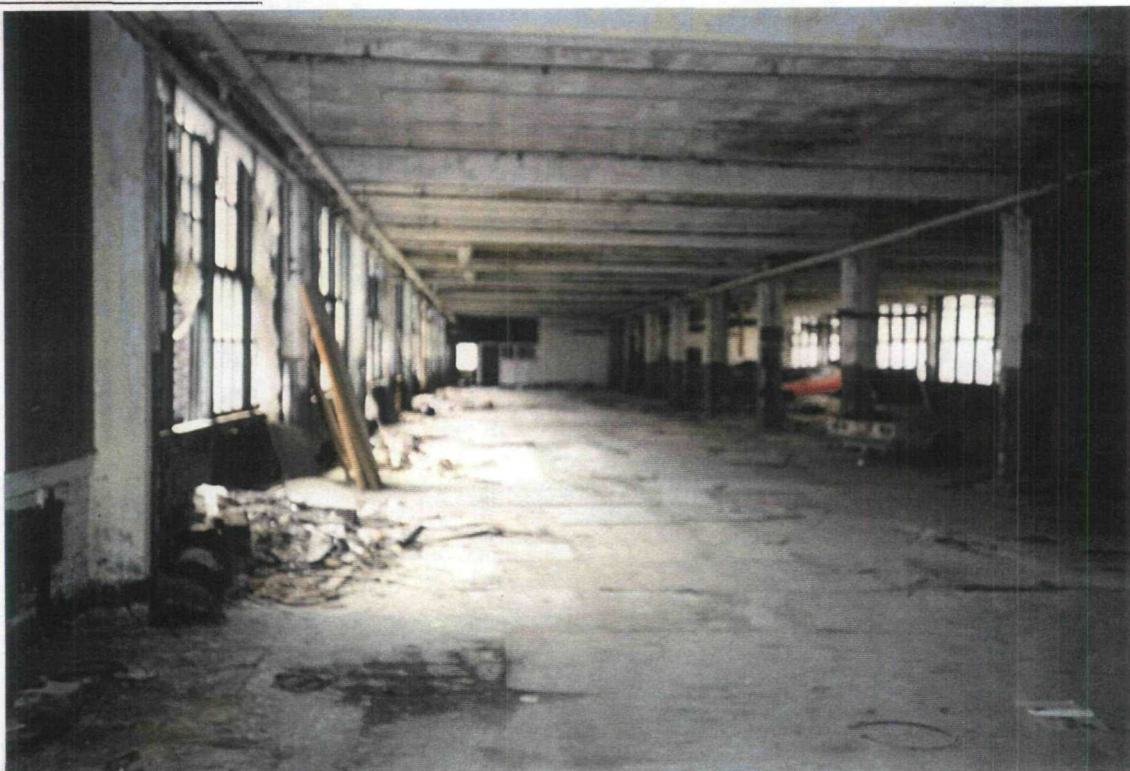
Second Floor of Building 1, used by tenant to store old cars and other miscellaneous items.

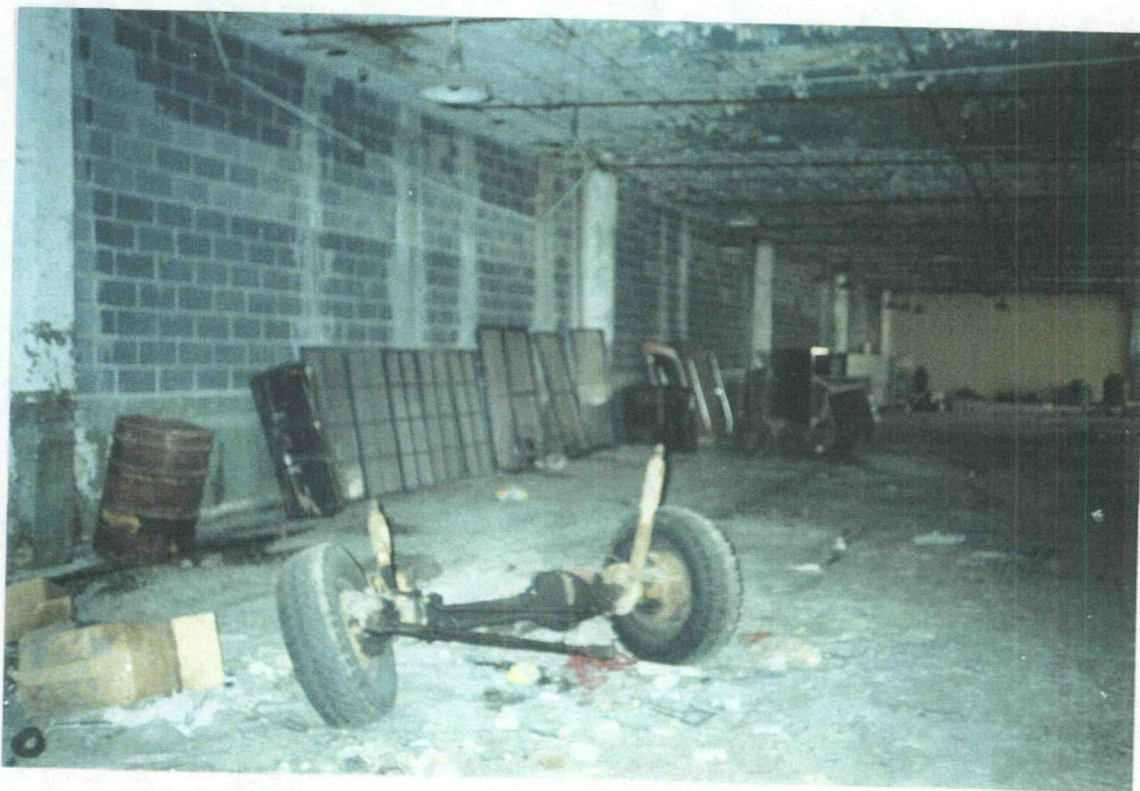
Second Floor of Building 2 and 2C used by tenant for storage of miscellaneous items.

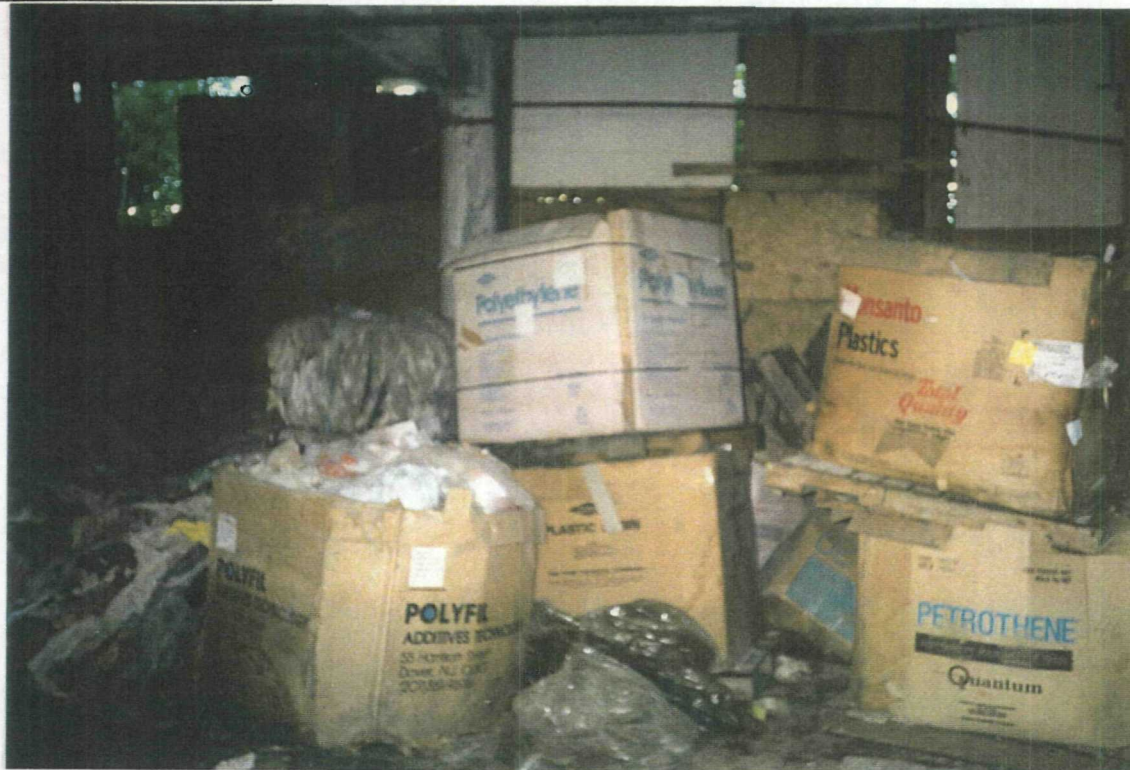
First Floor of Building 23, boxed, bagged and piled rags and plastic material.

- Removal of scattered debris including empty 55-gallon drums, 5-gallon buckets, wooden pallets, construction materials, old office furniture, tires, bundled rags, piled plastic pellets and other material noted during building audit walk through. This debris are located in Buildings 10, 11, 12, 1, 5, 4 and especially Building 23.

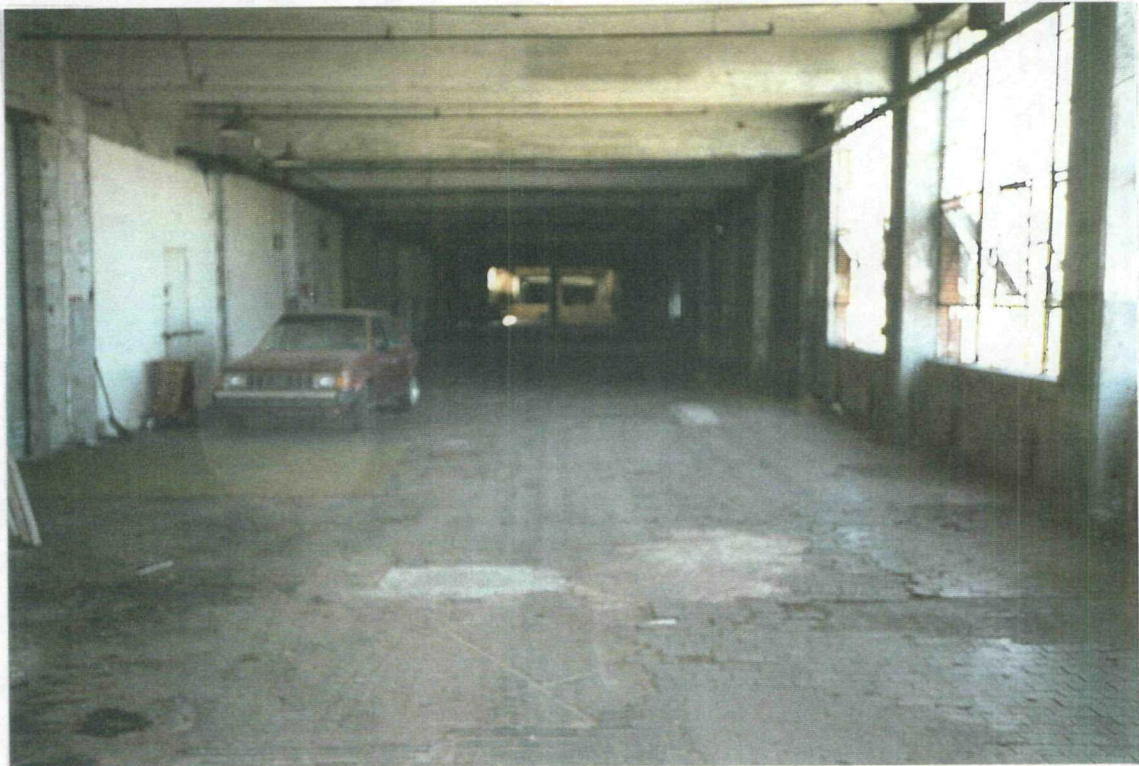
DESCRIPTION:  
Second Floor of Building 30. tenant storage area for cars and boats.

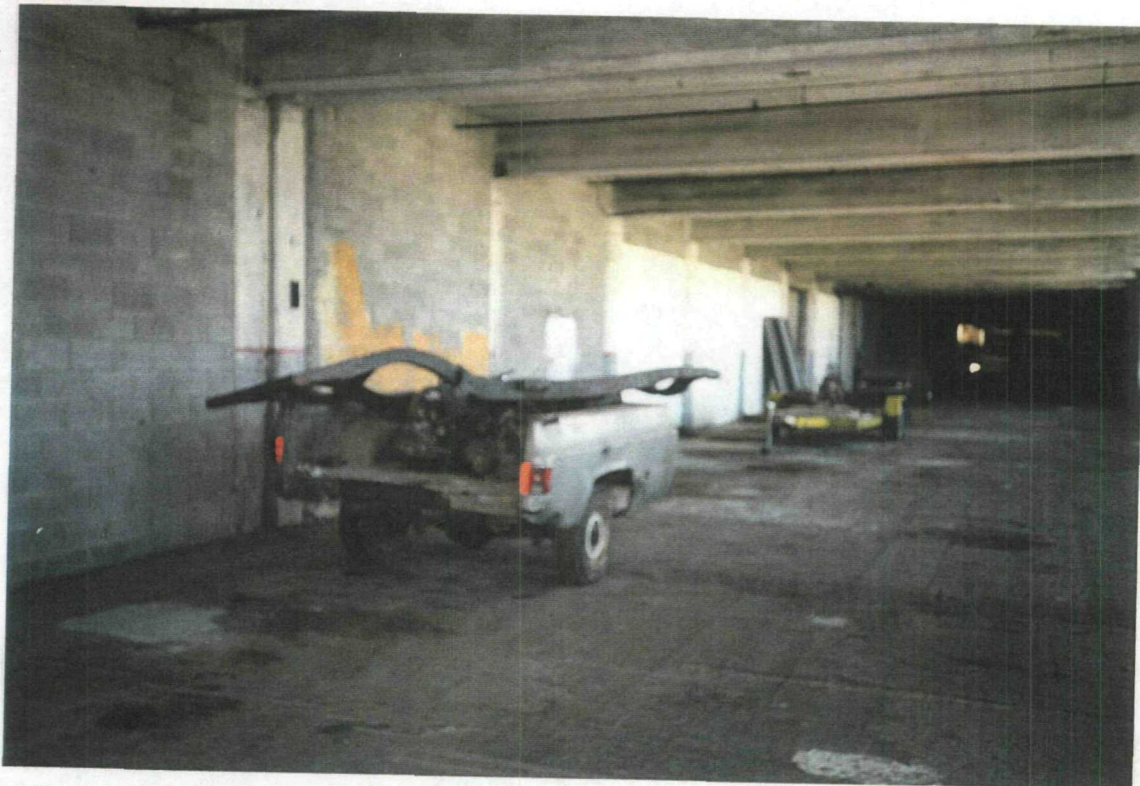
DESCRIPTION:  
Second Floor of Building 30. tenant storage area for cars and boats.

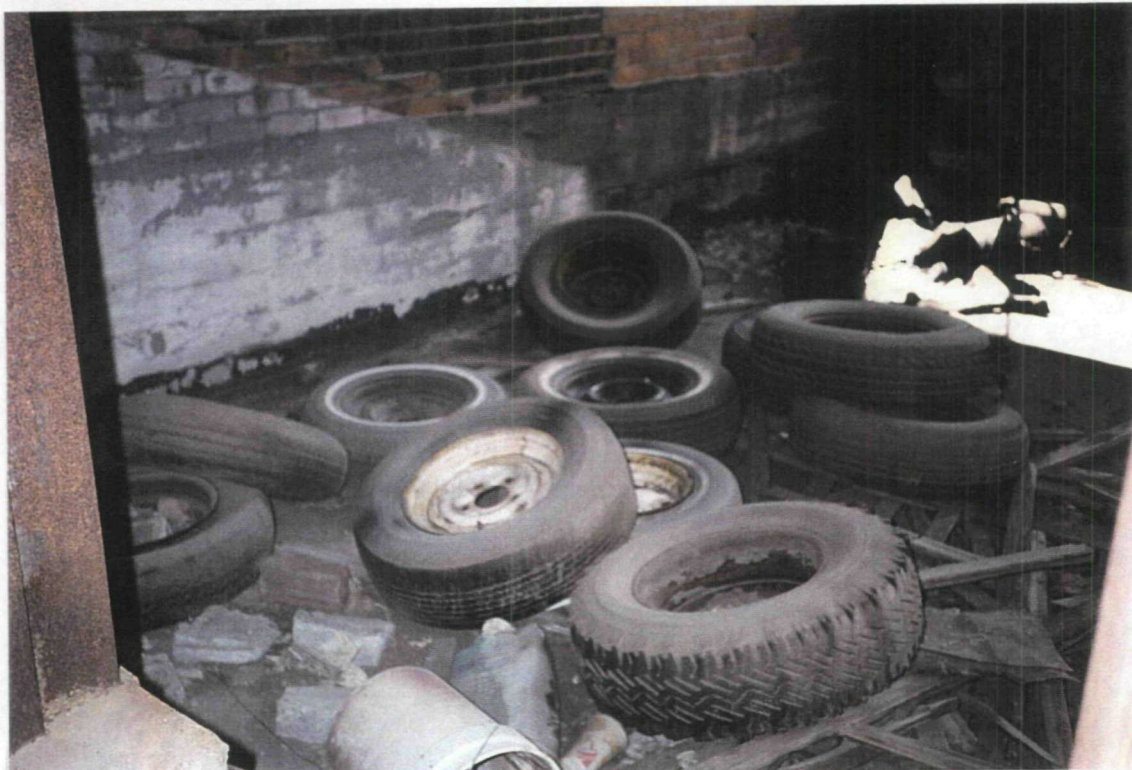
Second Floor of Building 35, opening onto roof, 12 tires and numerous 5 gallon buckets scattered here.

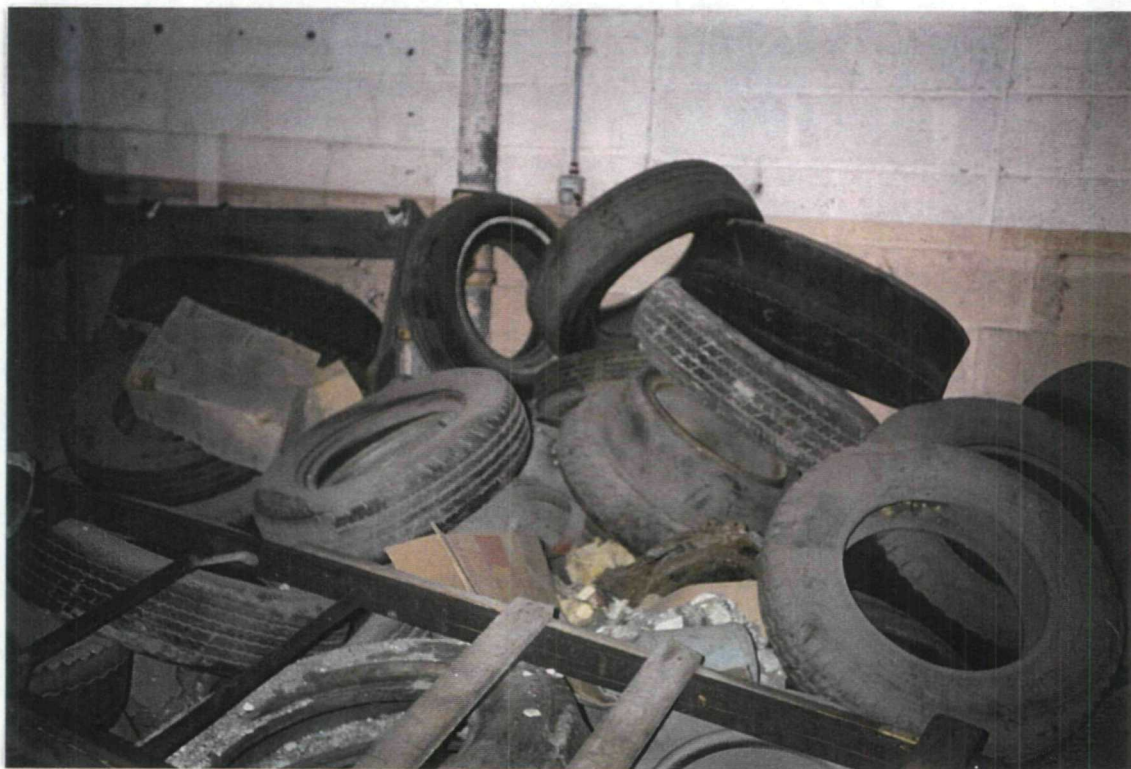
Second Floor of Building 92, bathroom at northeast corner, piled tires and other debris.

- Removal of approximately 500,000 used tires piled into the first floor at the south end of Building 38. Tires, present in such a large quantity, can be deemed a fire and environmental hazard. Additional piled tires are located in the second floor of Building 92.

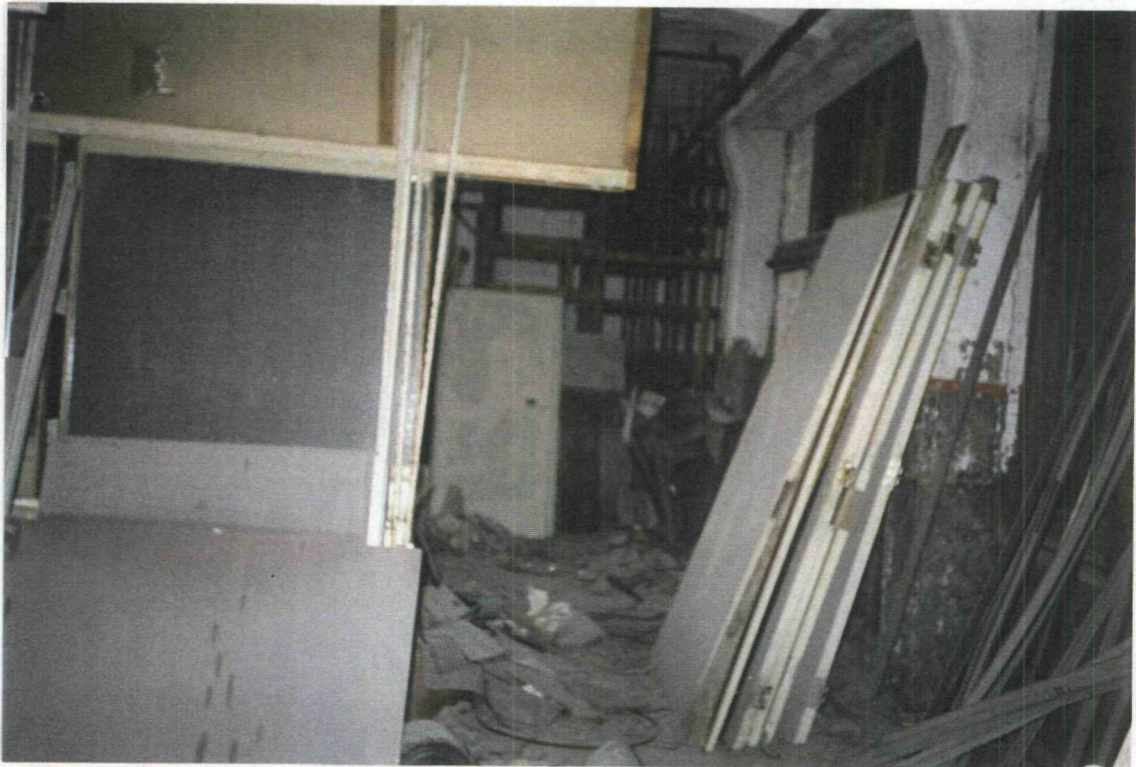
Third Floor of Building 16/11, tenant storage room stacked with wooden doors, metal, Ford Motor Company files.

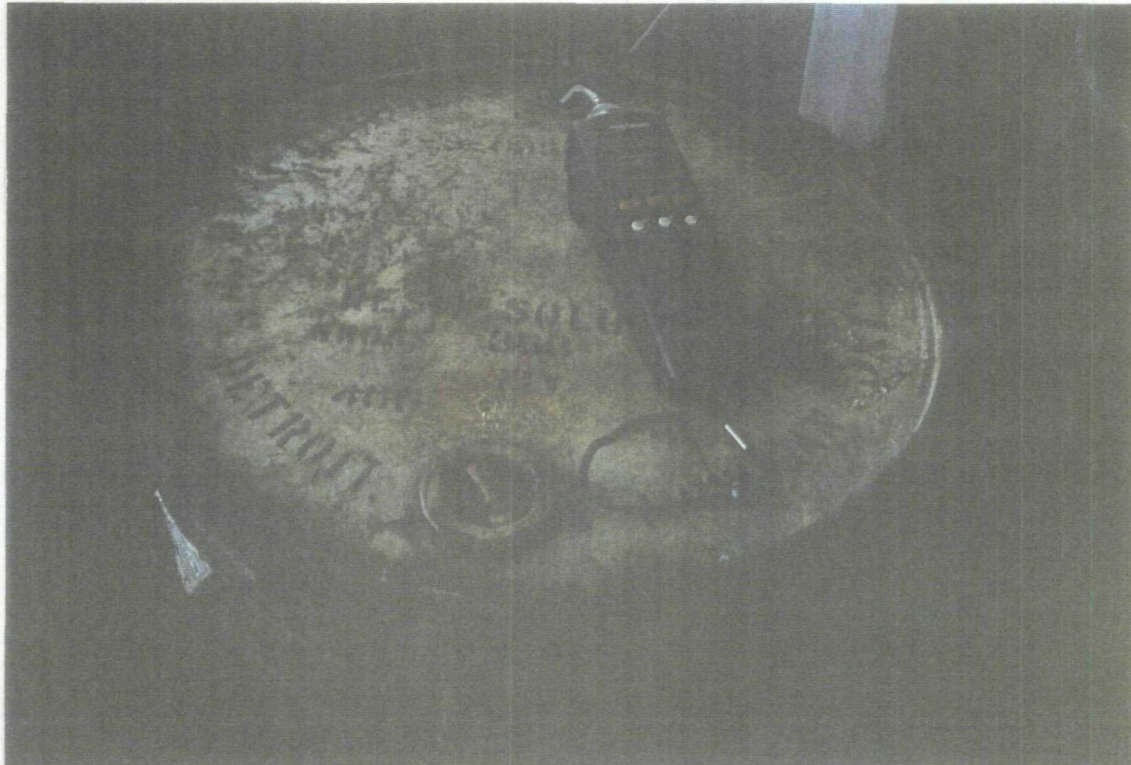
55 gallon drum labeled Reichold Chemicals Resin Solution, OVA reading of 63.9 ppm, partially full on Fifth Floor of Building 12.

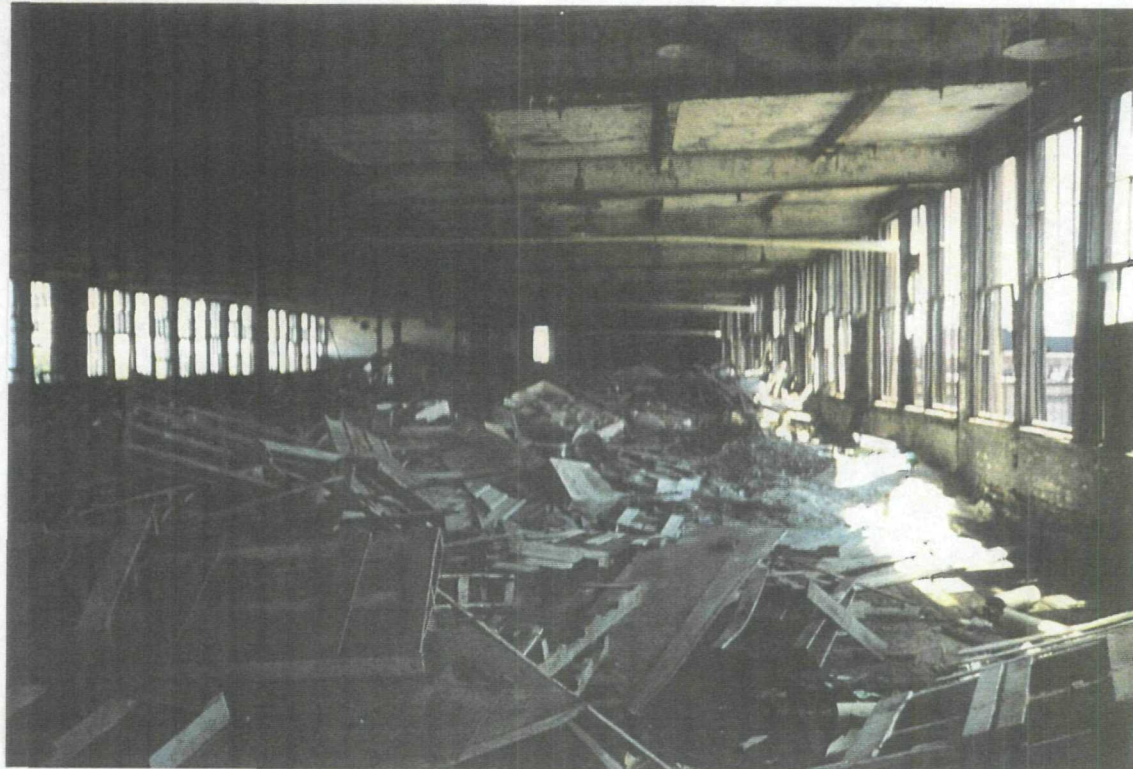
Fifth Floor of Building 12, piled wooden pallets, car parts, boats, drums other miscellaneous debris.

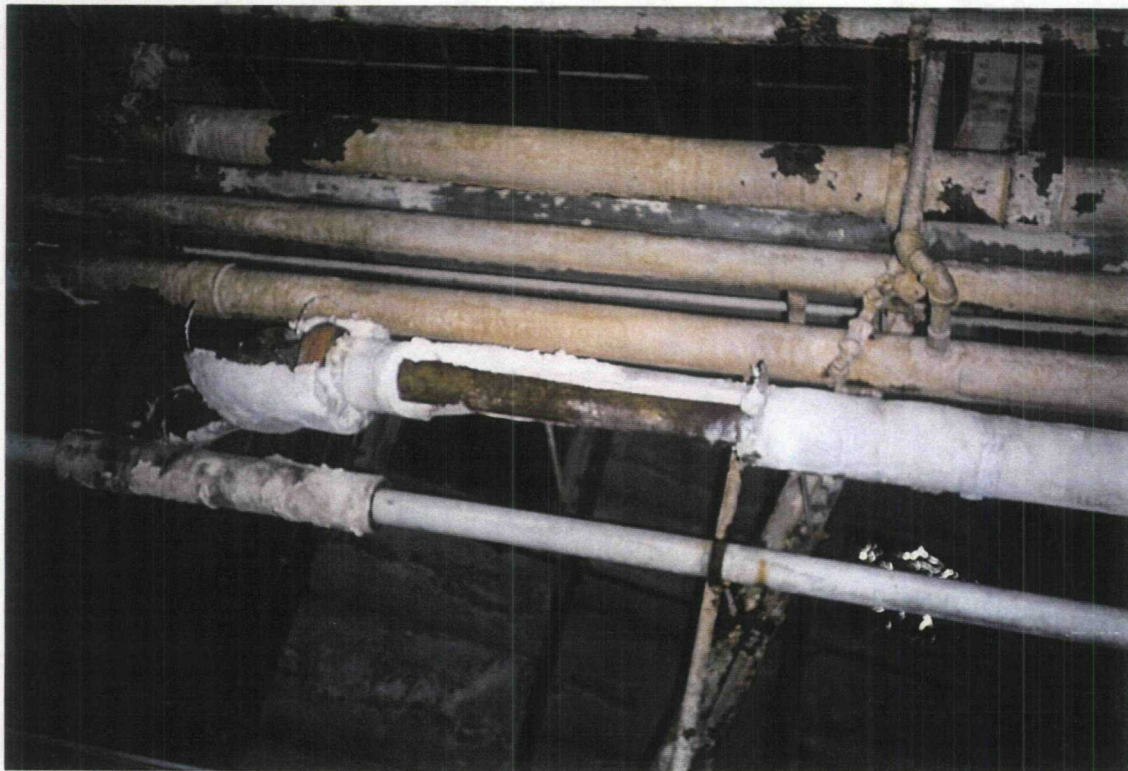
DESCRIPTION:  
Asbestos pipewrap (aircell) on pipes in southeast corner ceiling of first floor of Building 90 and 91.

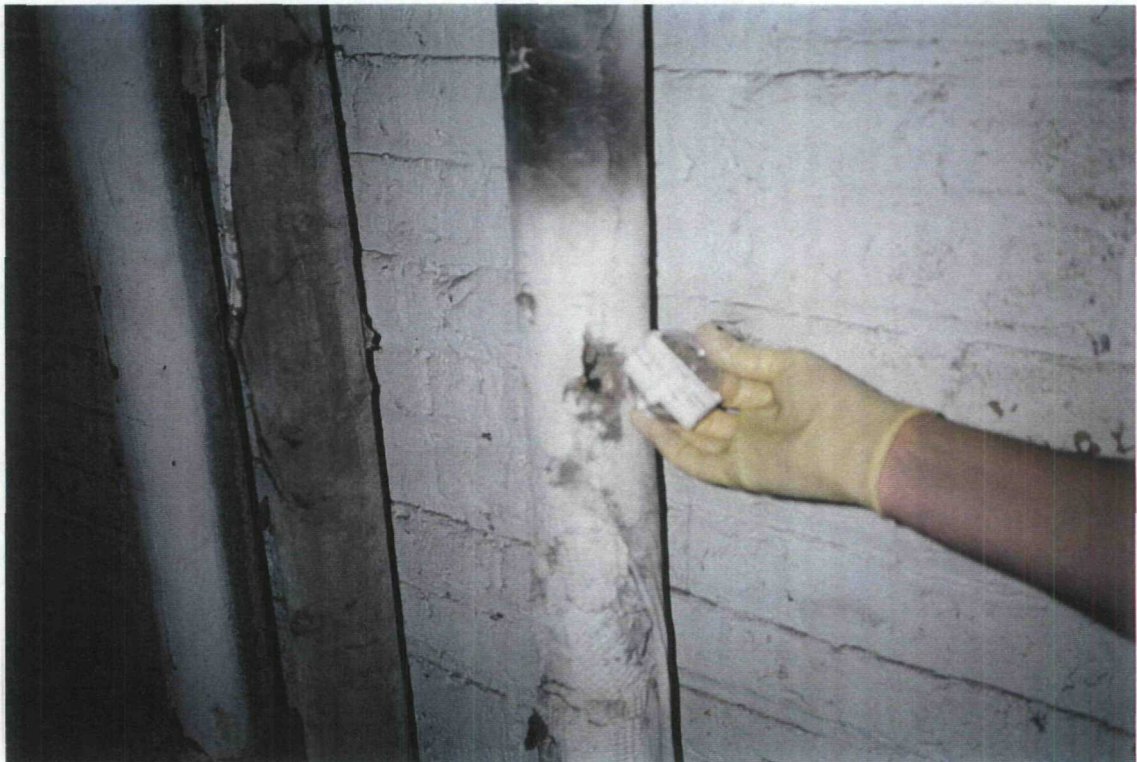
HA008-01

Pipewrap around venticle pipe along wall on first floor of Building 7; gray aircell, wrap around 2" diameter pipe; ~20 linear feet observed  
~20 linear feet observed on second floor

Aircell pipewrap on vertical pipes along wall on first floor of Building 7.

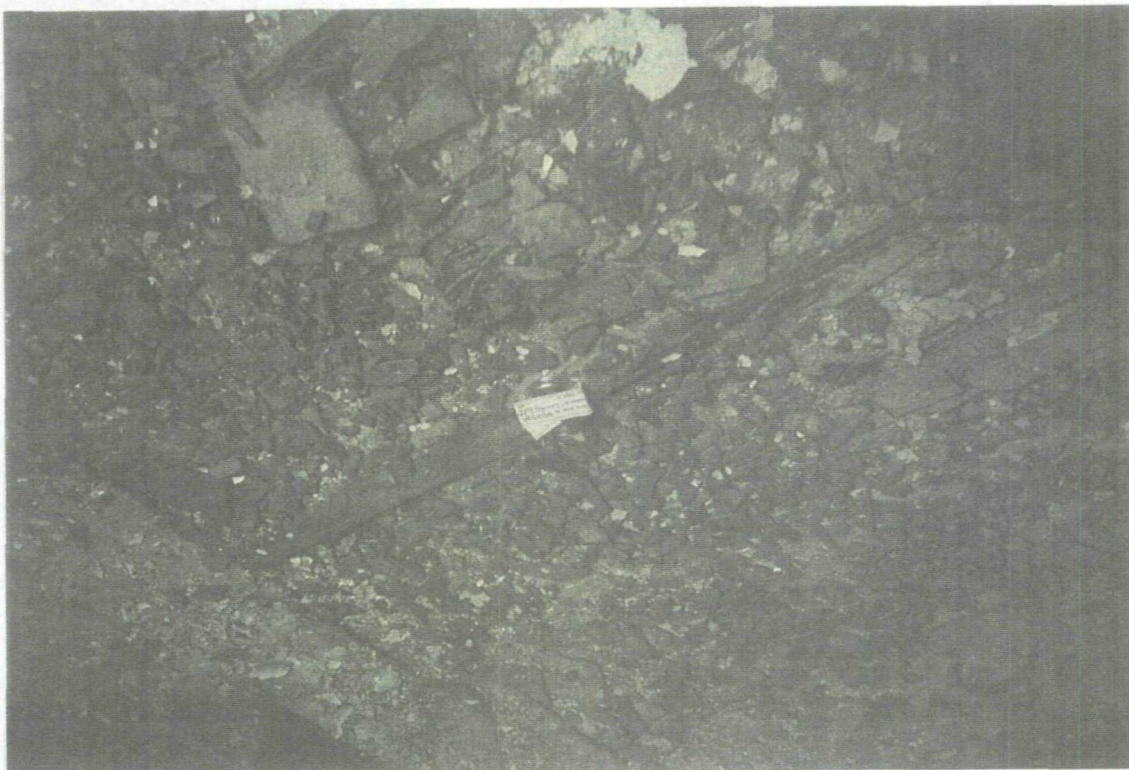
SAMPLE ID:  
HA009-01

Floor tile, from second floor office area Building 1 and 1C, Southwest corner of floor; 9"x9" square tile blue/green color, most of tile crumbly and broken  
~20'x20' = 140 square feet observed

Blue/green crumbled floor tile from office area, southwest corner of second floor of Building 1.

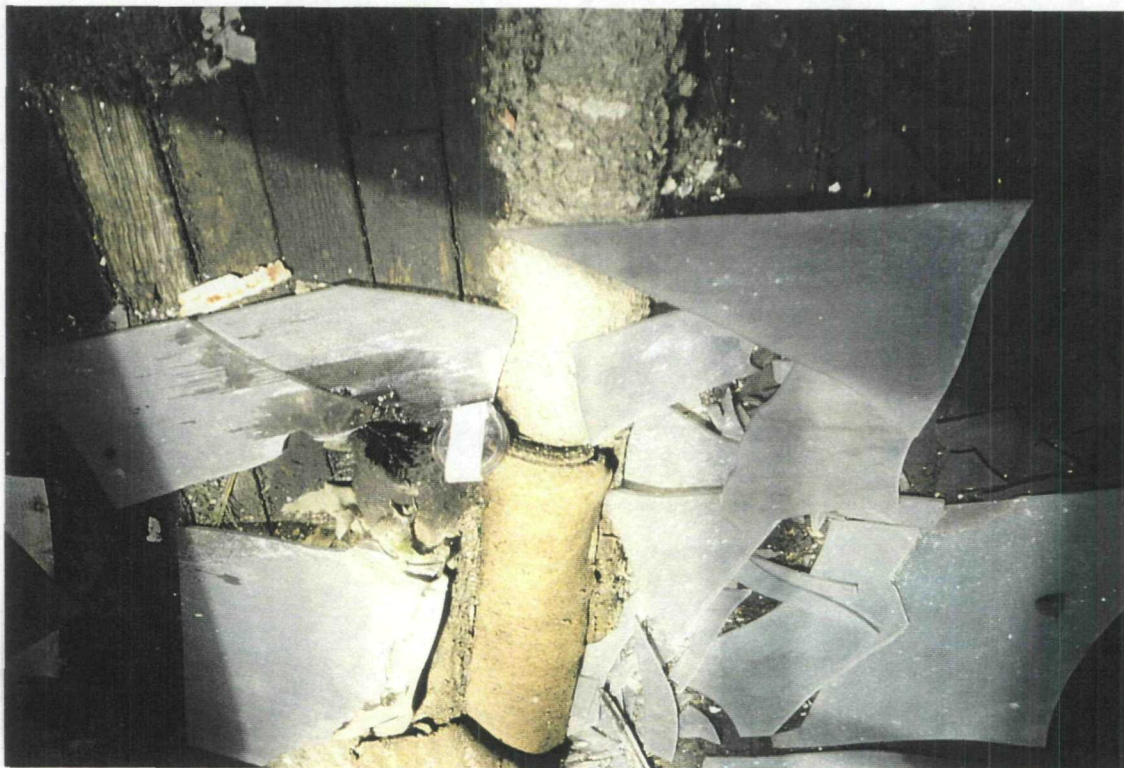
HA011-01

Pipe wrap from ceiling pipe on fourth floor of Building 1; sample collected from portion of wrap lying on floor; gray arcell; 2" diameter pipe ~ 100 linear feet of wrap observed

Aircell pipewrap on ceiling pipes on fourth floor of Building 1.

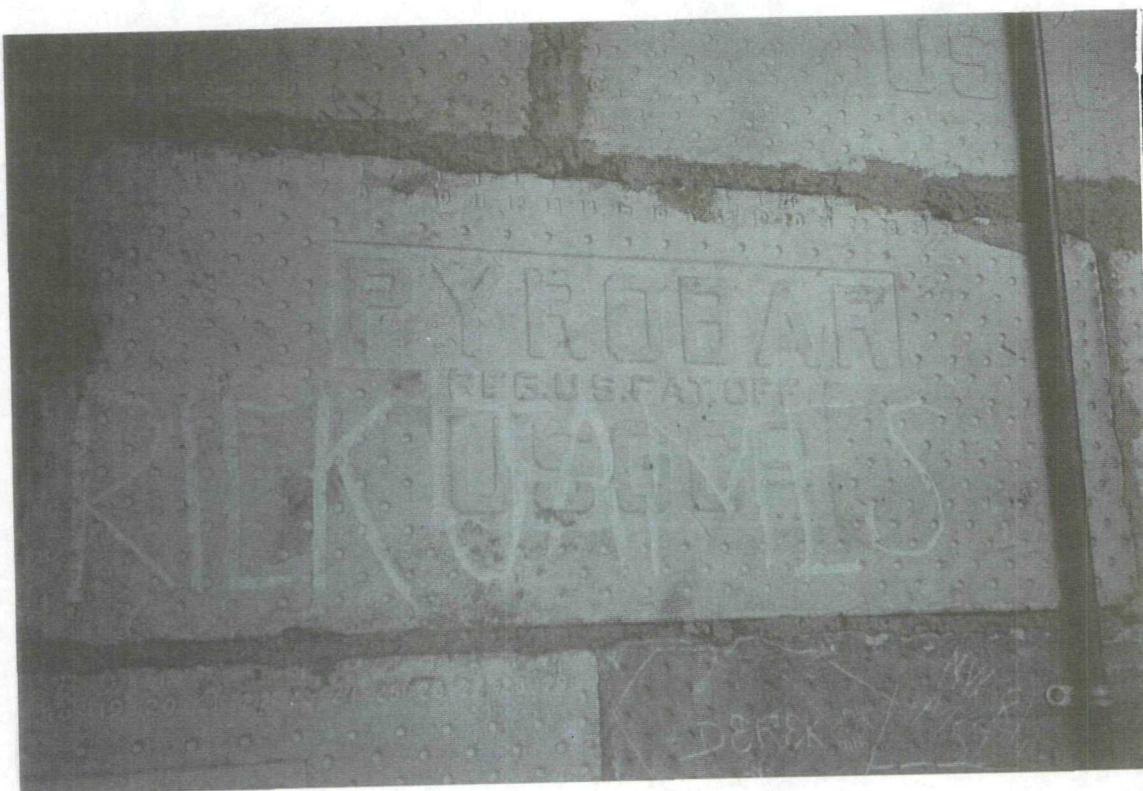
SAMPLE ID:  
HA01801

Pyrobar blocks in furnace room on fourth floor of Building 13.

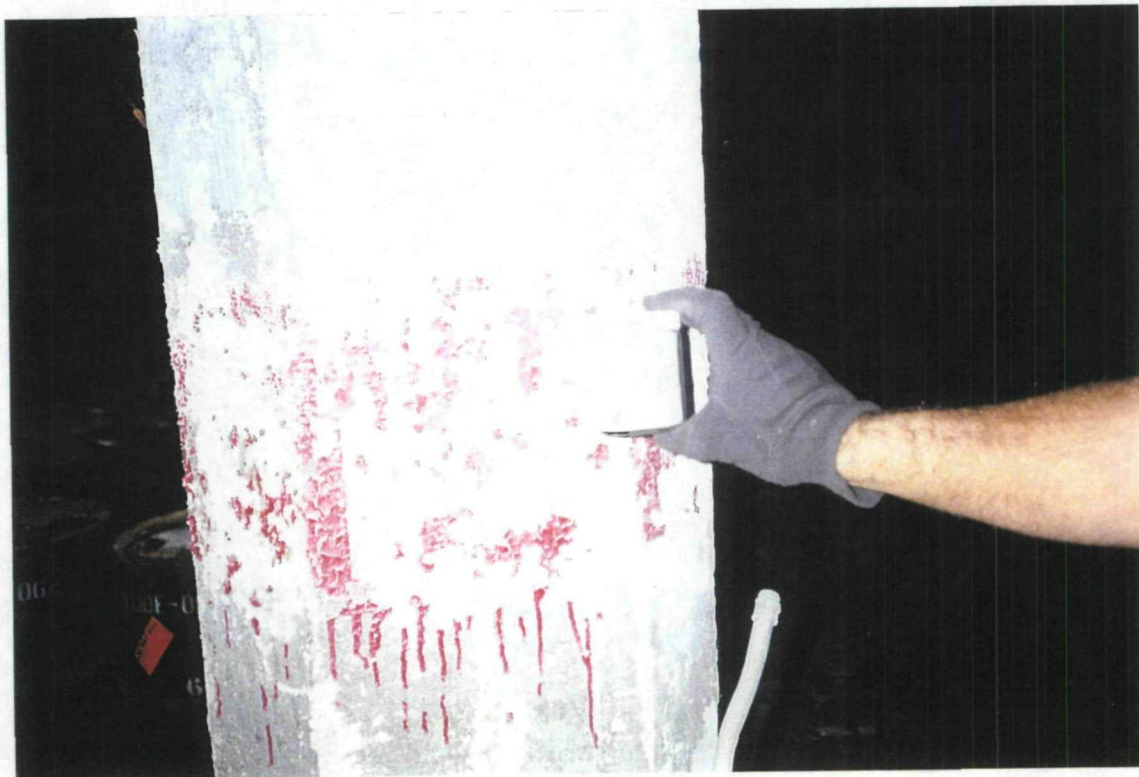
SAMPLE ID:  
PC 4

Paint Chip Sample 4 collected from square column on first floor of Building 23.
